# Study and Investigation of Mic (Microbial Influenced Corrosion) behavior on Stainless Steel with and without Coating

**Abstract:** MIC (Microbial Influenced Corrosion) is a type of corrosion that happened on a metal's surface under the seawater, MIC occurs due to the colonization of microorganisms on the surface, these micro-organisms may be fungus, bacteria, or algae. In this project, the E. Coli bacteria are used to investigate the MIC on stainless steel. Stainless steel is coated with a different coating such as rubber, graphene, locate, and epoxy. The samples with different coatings are tested to find out the best one which can resist MIC better than the others. There are different tests carried out; wet and dry test, and atmospheric test. To find the corrosion progress the weight loss and corrosion rate is found in the samples. The hardness of the coating is done to find the best one. The optical microscope is used to understand the corrosion progress on the metal surfaces.

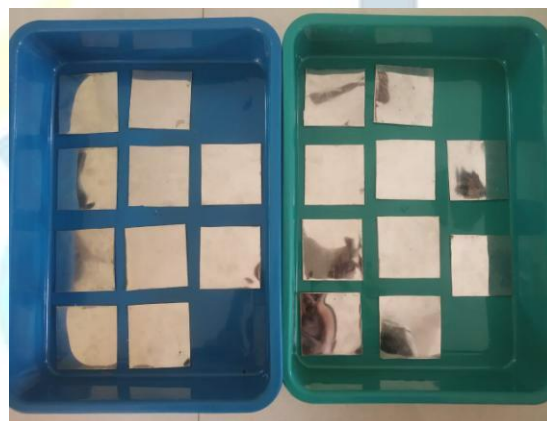
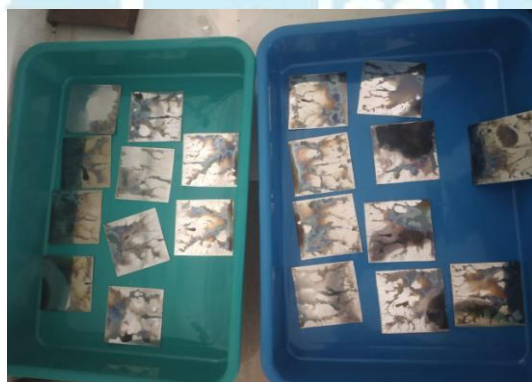
Figure 1: Mode of sample preparation before and after

1. The metal sample cut out into 20 pieces.
2. The specimens are cleaned by using hot water and acid for removing unwanted dust on the surface.
3. Sandpaper (with 100, 120, 180 number) used for blasting the metal samples.
4. After the blasting the samples are coated by different coatings (4 samples by rubber, 4 samples by alocit, 4 by graphene, 4 by epoxy and 4 without coating for comparing).
5. The samples distributed for each test 5 samples for differentiation.
6. Comparison between the metals in seawater without bacteria (*E. coli*) and metals in seawater with bacteria (*E. coli*).
